A strong earthquake of 2003 in Gornyi Altai

Abstract. The aim of this paper is to describe the macroseismic, geological, and seismological manifestations of the strong earthquake that occurred in the south of the Gornyi (Mountainous) Altai area on September 27, 2003. The earthquake caused damage to buildings and constructions in the area of the Chuya and Kurai depressions and was accompanied by the manifestation of the earthquake source on the ground surface with the formation of a system of WNW-oriented faults, which has been traced over a distance of 20 km in the region of the eastward plunge of the North Chuya Range. Secondary seismic dislocations manifested themselves in the form of rockfalls, landslides, and griffons in the area of the pleistoseist zone. The results of the preliminary study of the tectonic position of the earthquake source suggest that the Gornyi Altai is a direct continuation of the Mongolia and Gobi Altai areas, where earthquakes with magnitudes of more than 7.0 were recorded repeatedly, and allow us to combine all of the mountain systems of the Great Altai into one high-magnitude seismotectonic province.

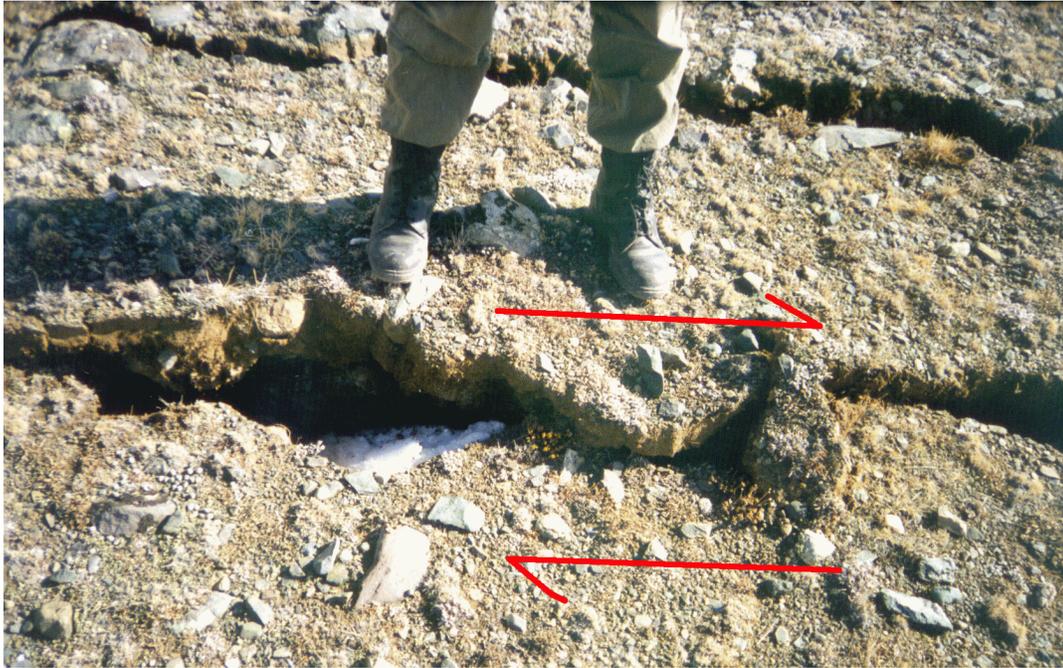
Figure 3. Right-lateral strike-slip fault.

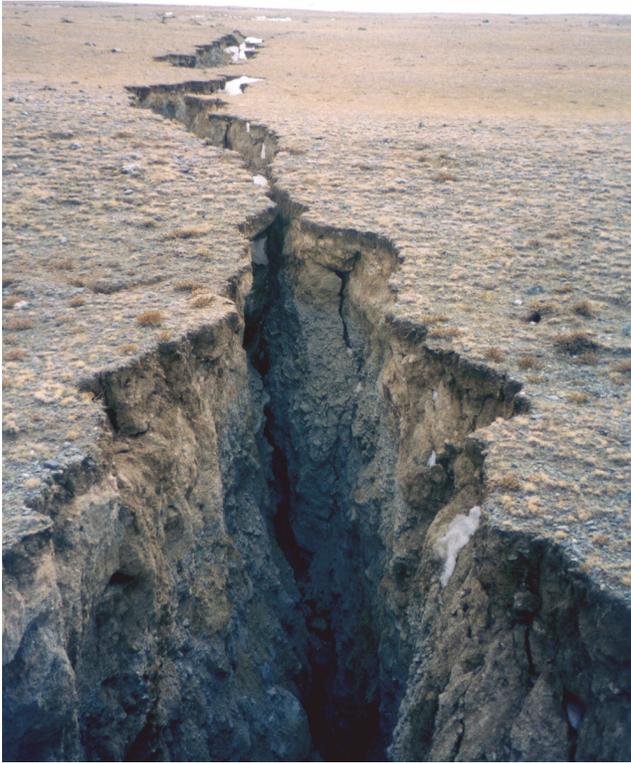
Figure 5. Seismic trench showing differences in the small topographic forms of the opposite sides of a fracture, which were used to estimate the amplitude of the right-lateral offset.

The seismic fracture continues in the NW direction as an extensive trench with a maximum width of 1.5 m and descends into the valley of the Chagan River (Figure 5). Here, in addition to extension, the fault shows a right-lateral displacement of max. 0.5 m, which is recorded by the offset of individual small topographic forms. In the watershed of the Chagan and Taldura rivers the seismic source outcrops as a system of seismic trenches (detachment fissures) with openings of 1–3 m and a maximum length of 100 m

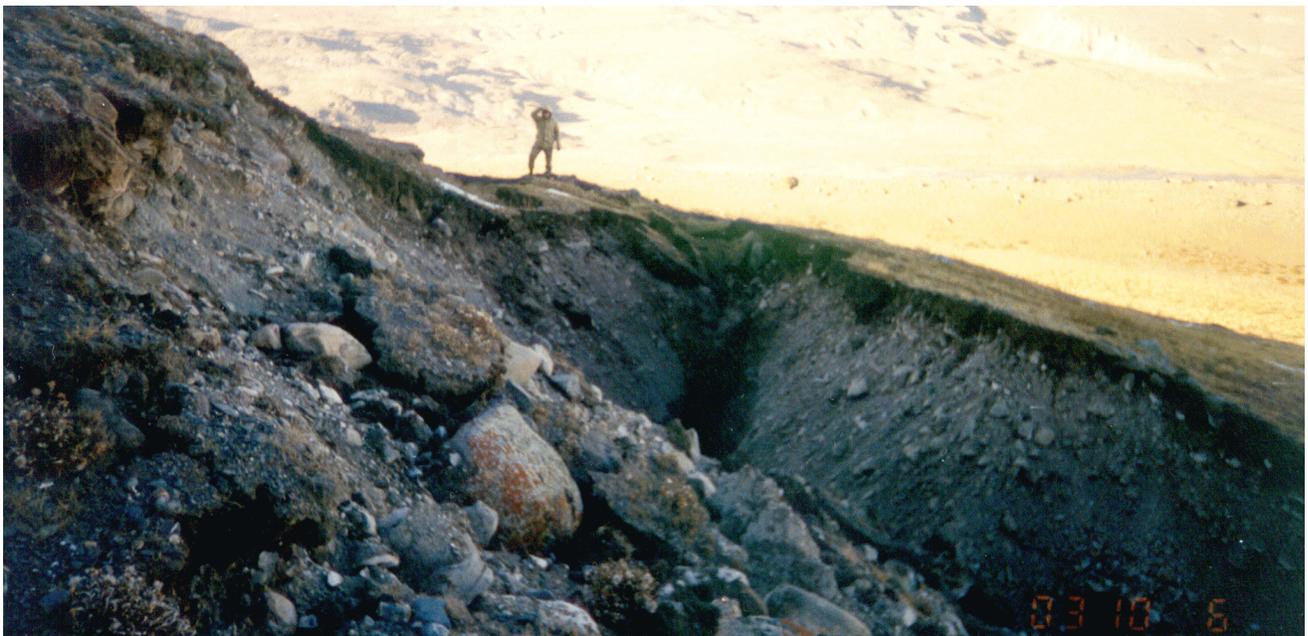
Figure 6. Seismic trench in the watershed between the Chagan and Taldura rivers.

(Figure 6). The trenches have orientations of about 320° and are arranged en echelon to form a zone striking 300° – 310° . Throughout the segment described the faults cross the Middle-Lower Pleistocene glacial boulder-pebble deposits.

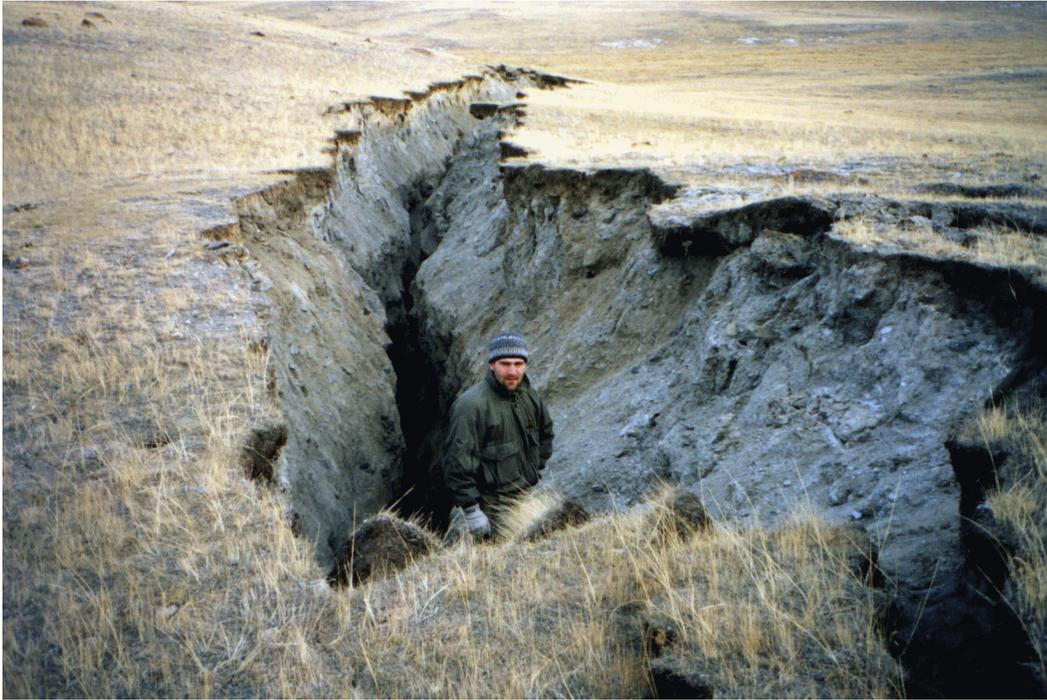
Figure 8. Seismic fault of the earthquake and man's figure inside the fissure for the scale.

wide in width, up to 300 m long, and >30 m deep (Figures 8 and 9). Judging by some of the gaping fissures, the amplitude of the right-lateral displacement is as large as 0.5 m (Figure 10). The zones of compression are represented there by dextral pressure ridges, up to 2 m high and up to 50 m

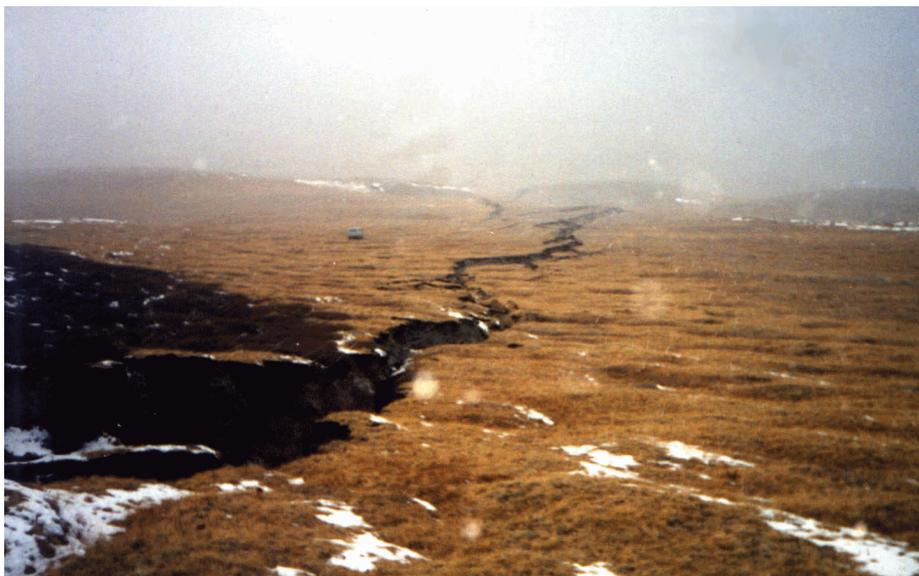
Figure 9. Seismic fault – the perspective view.

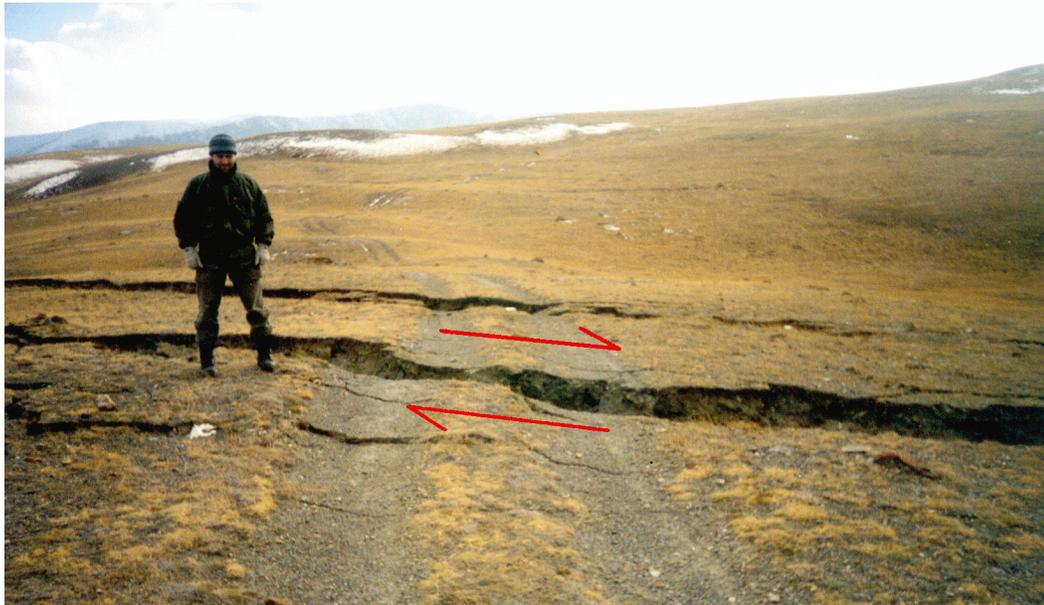
Figure 10. Right-lateral 0.5 m displacement.

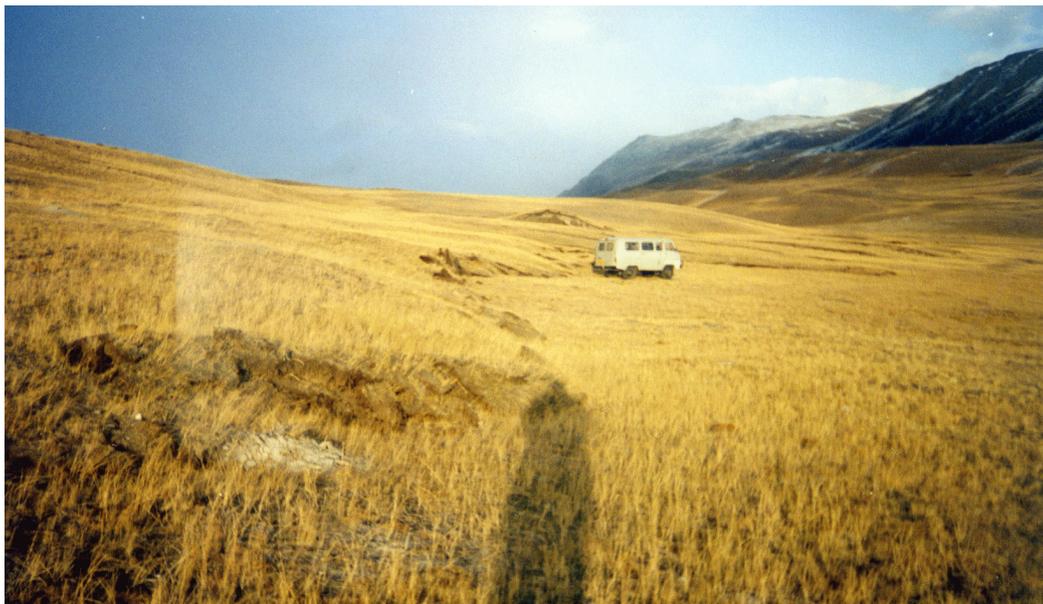
Figure 11. Compression ridges.

long, and by the overthrust scarps doubling the soil layer (Figure 11).

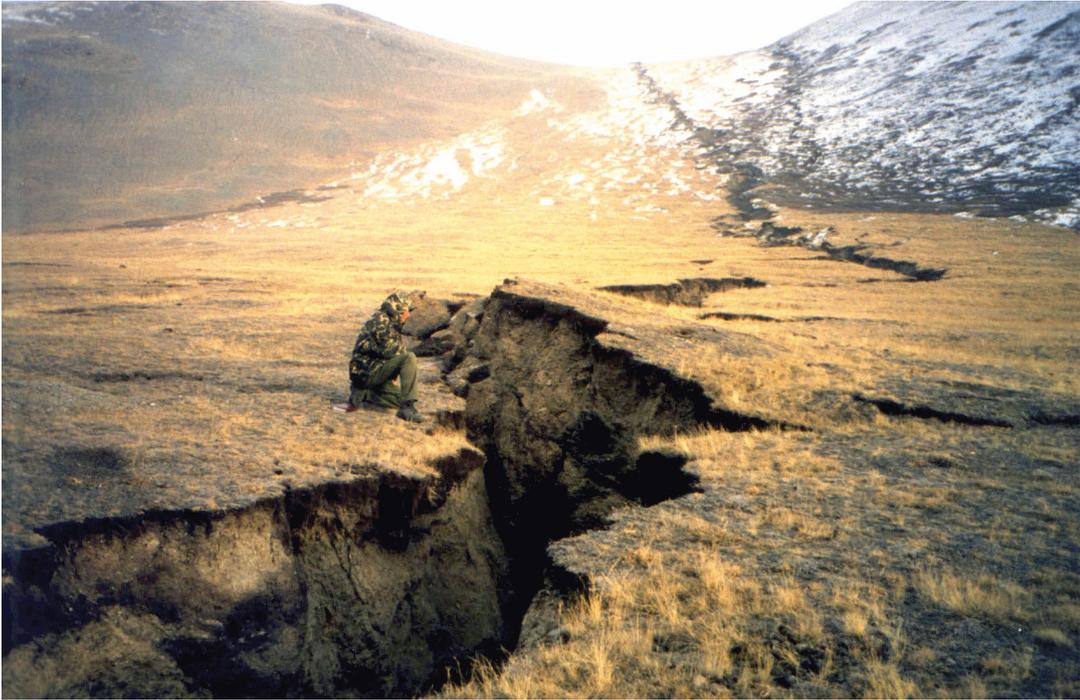
Figure 12. The breaking of the fault into two branches with a downthrown block between them.

the eastern side of the saddle this micrograben is not more than 50 m wide. The amplitude of its down warping is about 0.5 m (Figure 12). On the western slope the omitted block is up to 500 m wide, the maximum depth of its subsiding is 2.5 m (Figures 13 and 14). In both cases the micrograbens are restricted to small saddles. The faults are clearly expressed in the topography there as the benches separating

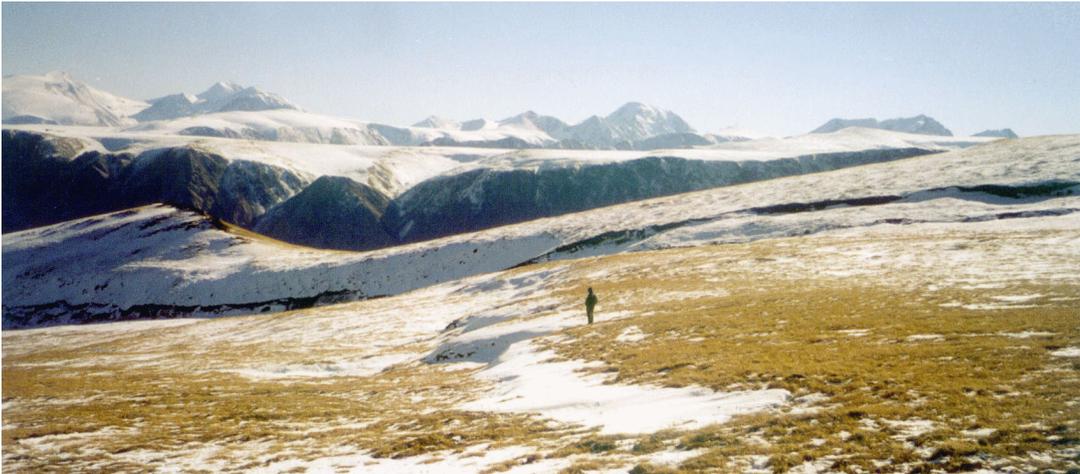
Figure 13. The southeastern branch of the fault, showing an old swelling rampart.

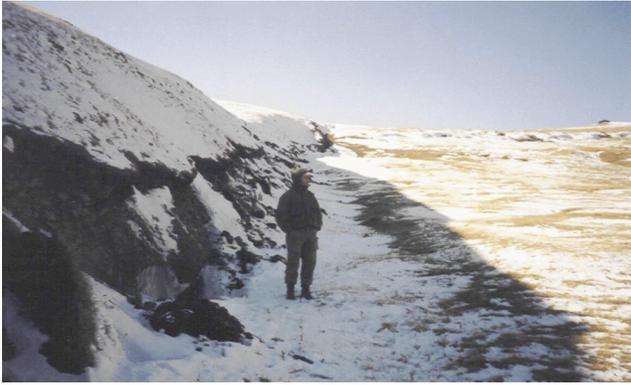
Figure 15. The southeastern branch of the fault (a closer view). The amplitude of the micrograben descendance is about 2 m.

the flat floors of the saddles composed of loose deposits from the relatively steep slopes where Devonian bedrock schists are exposed (Figure 15). The seismogenic displacements of September 27 merely rejuvenated these scarps.

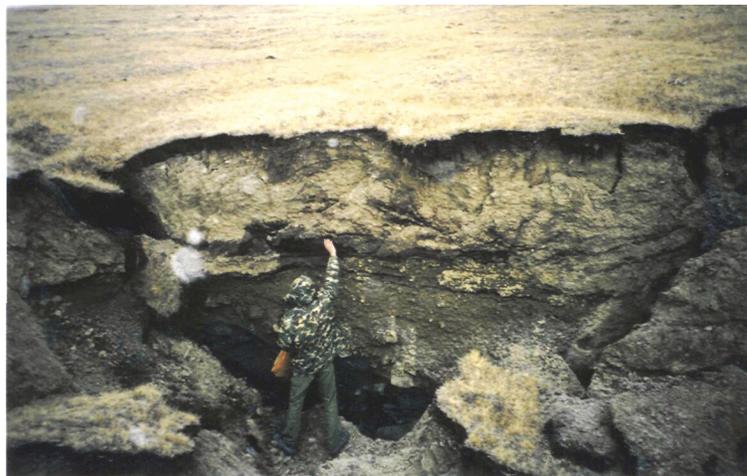
Figure 16. The buried paleosoil lenses in the wall of gapping fissure.

main shock of the last earthquake (Figure 14). The walls of the open fissures often show the traces of the crushing and ferrugination of the loose sediments, and also the wedges and lenses of ancient soil and peat, buried under the coarse clastic material (Figure 16). These facts prove the previous seismic events there, which might have been comparable with or, potentially, greater than the earthquake of September 27, 2003.

According to new results of radiocarbon dating of the paleosoil and peat samples these high magnitude seismic events could occur in 3340 ± 30 , 1780 ± 30 and 1280 ± 30 years b.p. (samples No. 2817, 2823 and 2818 IGAN). Thus, the observed recurrence interval might be of 500–1500 years.

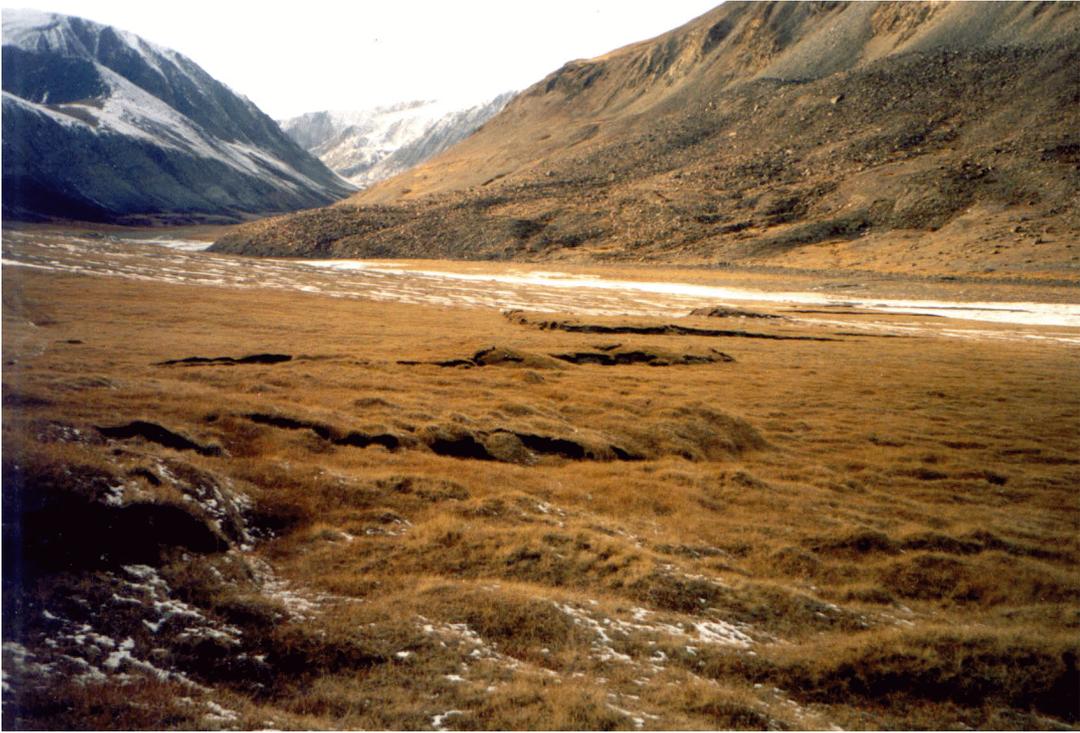
Figure 18. The close view of the seismic fracture in the Kuskunur valley, clearly showing a conjugated system of extension and compression breaches (gashes and moles).

are arranged into a zigzag-shaped system of moles and gashes and cross the alluvial pebble and gravel deposits (Figure 18). The system of seismic faults is marked there by the ridges of compression and overthrusting of the modern soil horizon (striking 40° – 60°) and by trenches open to a width of 1 m

and up to 3 m deep. The dextral offset of the road by extension fissures is of 0.3–0.4 m. The moles are as high as 0.5–1 m. The compression (moles) and extension (gashes) breaches have approximately equal lengths not exceeding 50 m. The faults cross the valley and extend to the op-

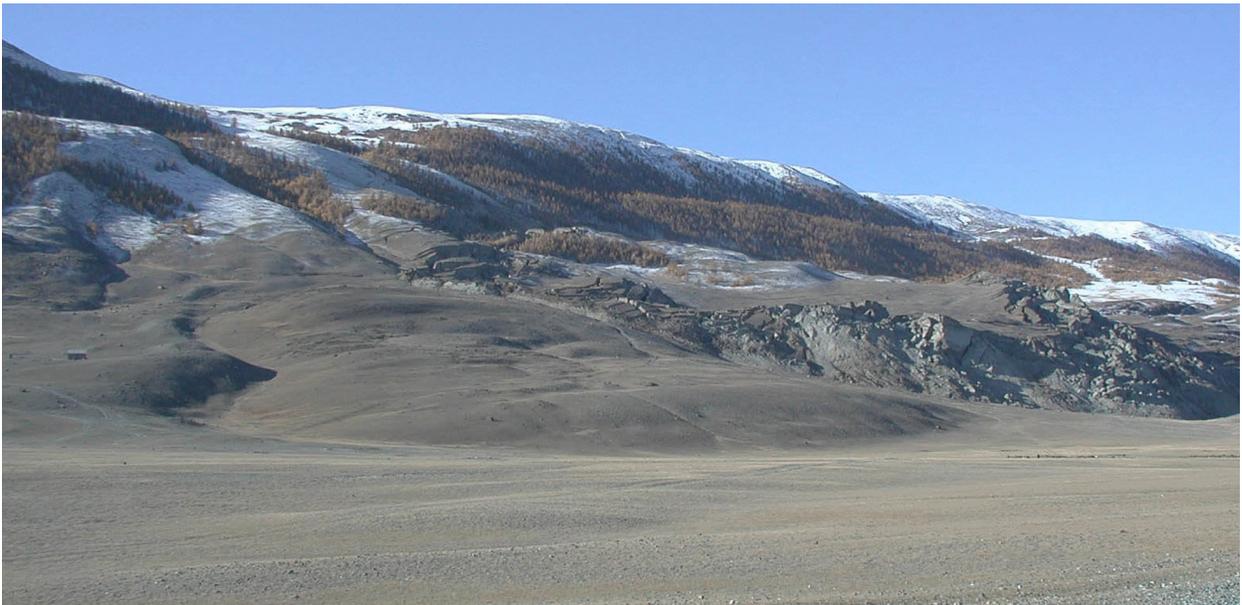
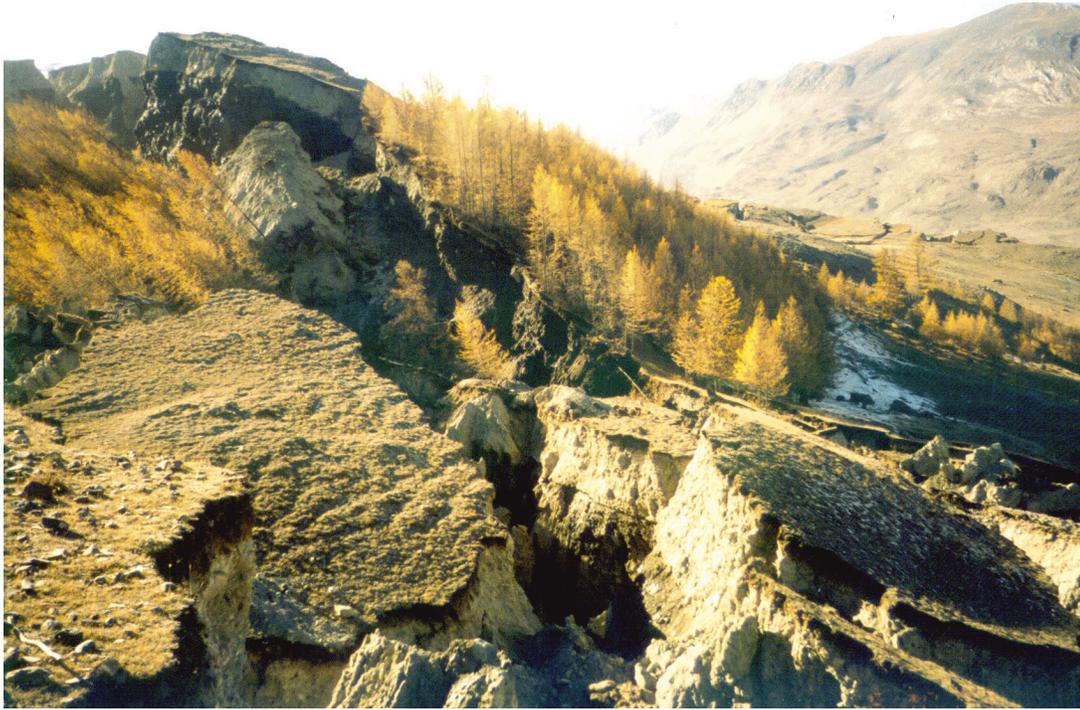
Figure 19. The general view of the landslide.

Figure 20. Fissures in the landslide body.

The largest trace of the earthquake, a major landslide at the right-hand side of the Taldura River valley, is restricted to the area where the earthquake source had reached the ground surface. The wall from which the landslide masses had been collapsed is restricted exactly to the zone where the primary seismic breaks had developed. One of them had initiated the landslide motion. The landslide had been detached from the rupture wall at the height of about 150 m and had traveled into the valley over a distance of not less than 100 m. The volume of the landslide rock mass was

calculated to be about 30 million cubic meters. The width of the landslide body is >500 m, its length being about 700 m (Figures 19 and 20). Similar landslides of smaller sizes had been formed at the slopes of the Chagan and Chagan-Uzun river valleys.

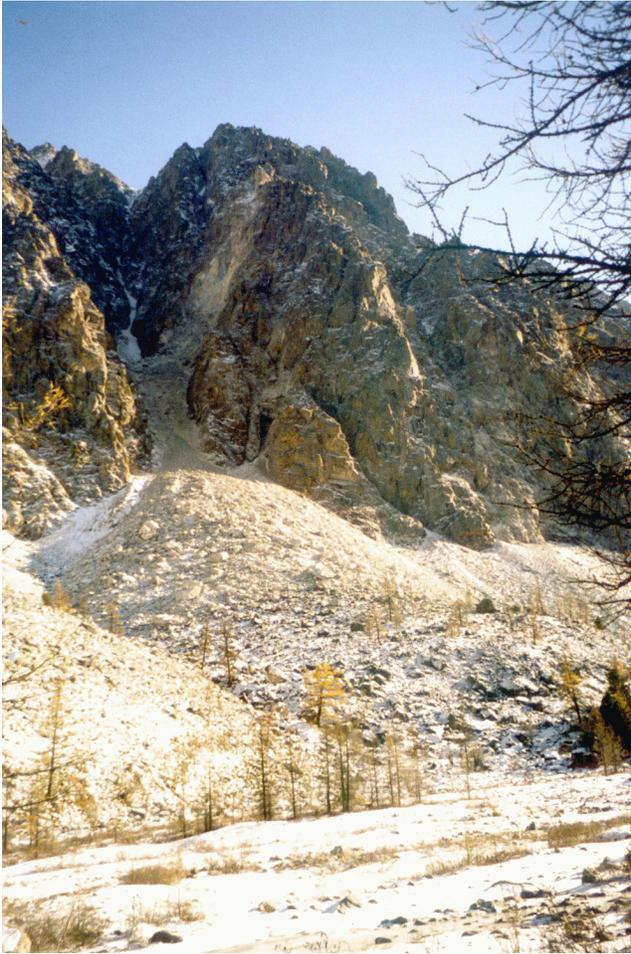
Figure 21. A rockfall in the valley of the Akturu River.

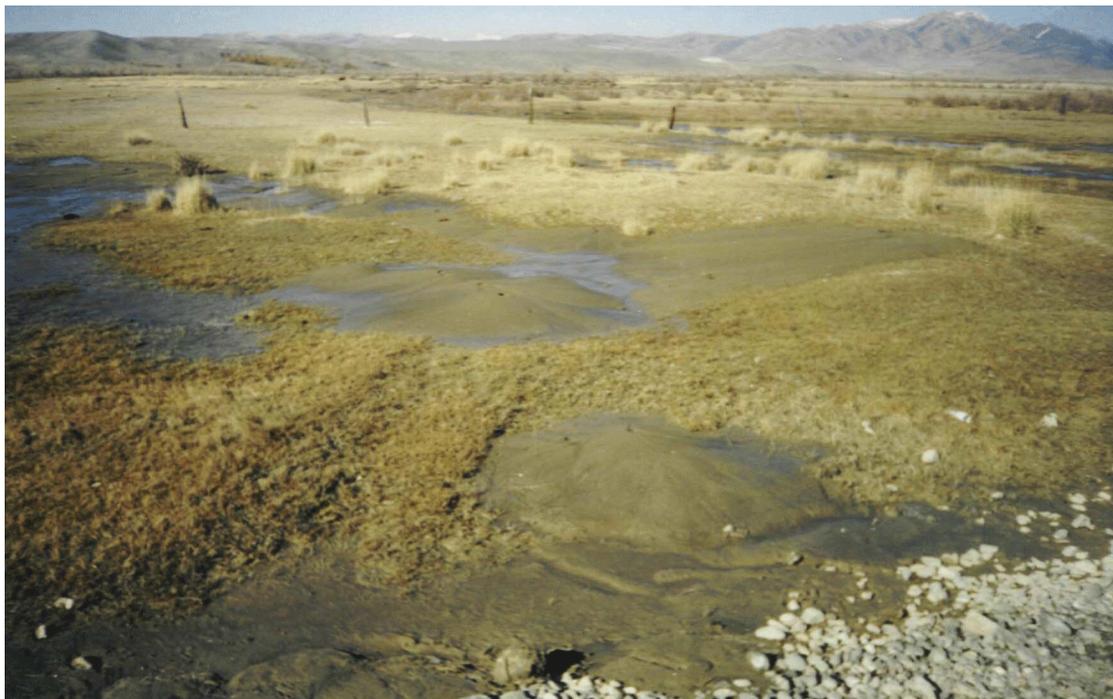
Figure 22. Mud gryphons in the Chuya R. valley.

ble of being liquefied and flowing to the ground surface in the form of small cone- or funnel-shaped mud volcanoes and compensation ground surface subsidence (Figure 22). This is usually a ground-surface process operating at a depth less than 20–30 m. In our case the lower boundary of the process was the permafrost top. In most cases gryphons are restricted to short open fissures of vibration or seismogravitational nature (Figures 23 and 24). The close vicinities of seismic fault zones showed the large flows of liquefied sand from open seismic-vibration fissures with a maximum length of 50 m. A striking example is the floodland of the Taldura River.

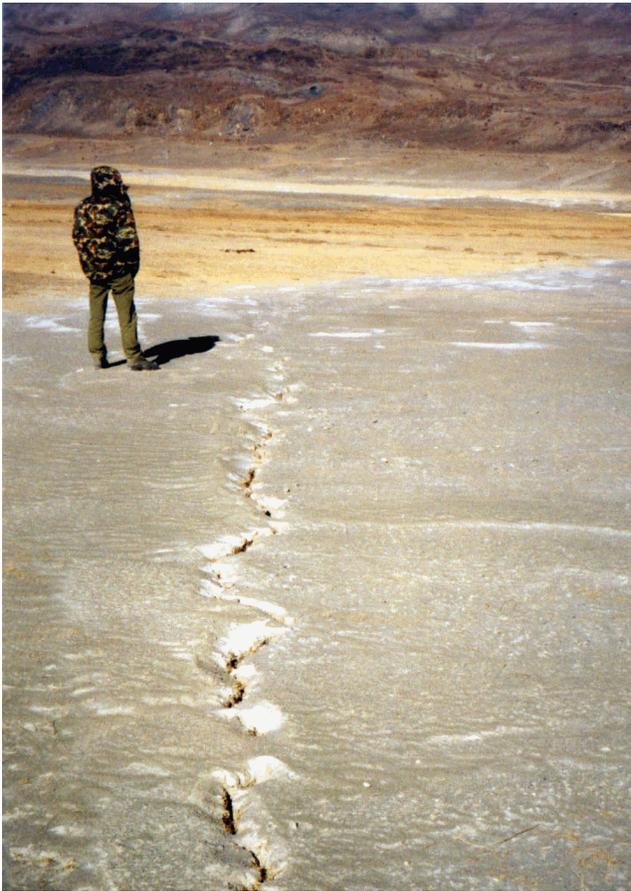
Figure 24. Areal spread of liquefied sand from a fissure in the Taldura River flood plain.

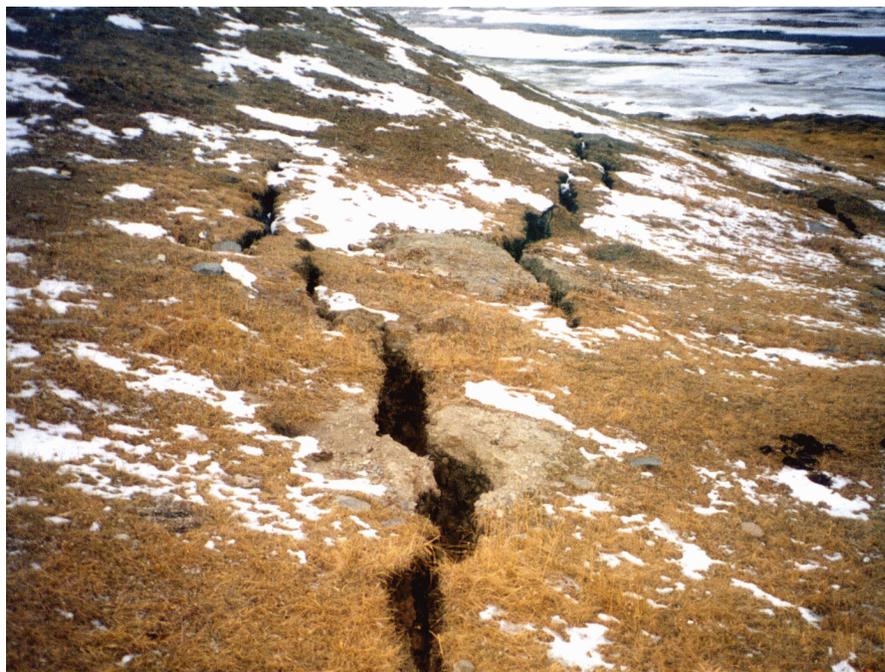
Figure 26. Gravel and sand material ejected from the open fissures.
